**National Highway
Traffic Safety
Administration**

Case Vehicle (A): 2000 Ford
Type: Expedition Eddie Bauer 4 x 4, 4-door SUV
Driver: 50-year-old female
CDC: 12-FRLE-3

Vehicle (B): 1989 Ford
Type: Taurus LX, 4-door sedan
Driver: 33-year-old female
CDC: 99-0000-0

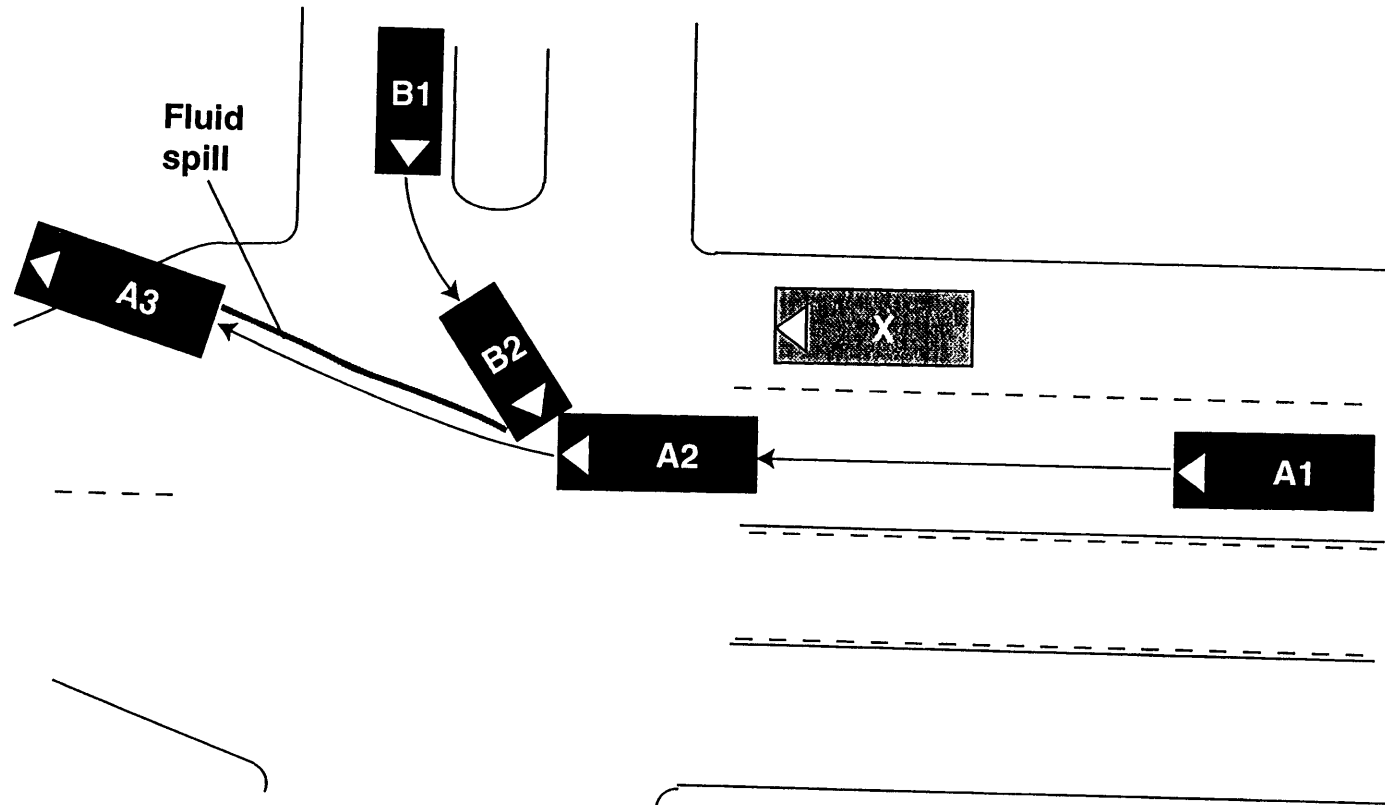
ACCIDENT SCHEMATIC

ACCIDENT DESCRIPTION: Case vehicle (A) WAS TRAVELING WEST
ON A 4-lane asphalt road. Vehicle (B) was exiting
A parking lot, AND went into the path of case
vehicle (A). The right-front of case vehicle (A)
contacted the left-front of
vehicle (B). Case vehicle (A) proceeded to override the front of vehicle (B)

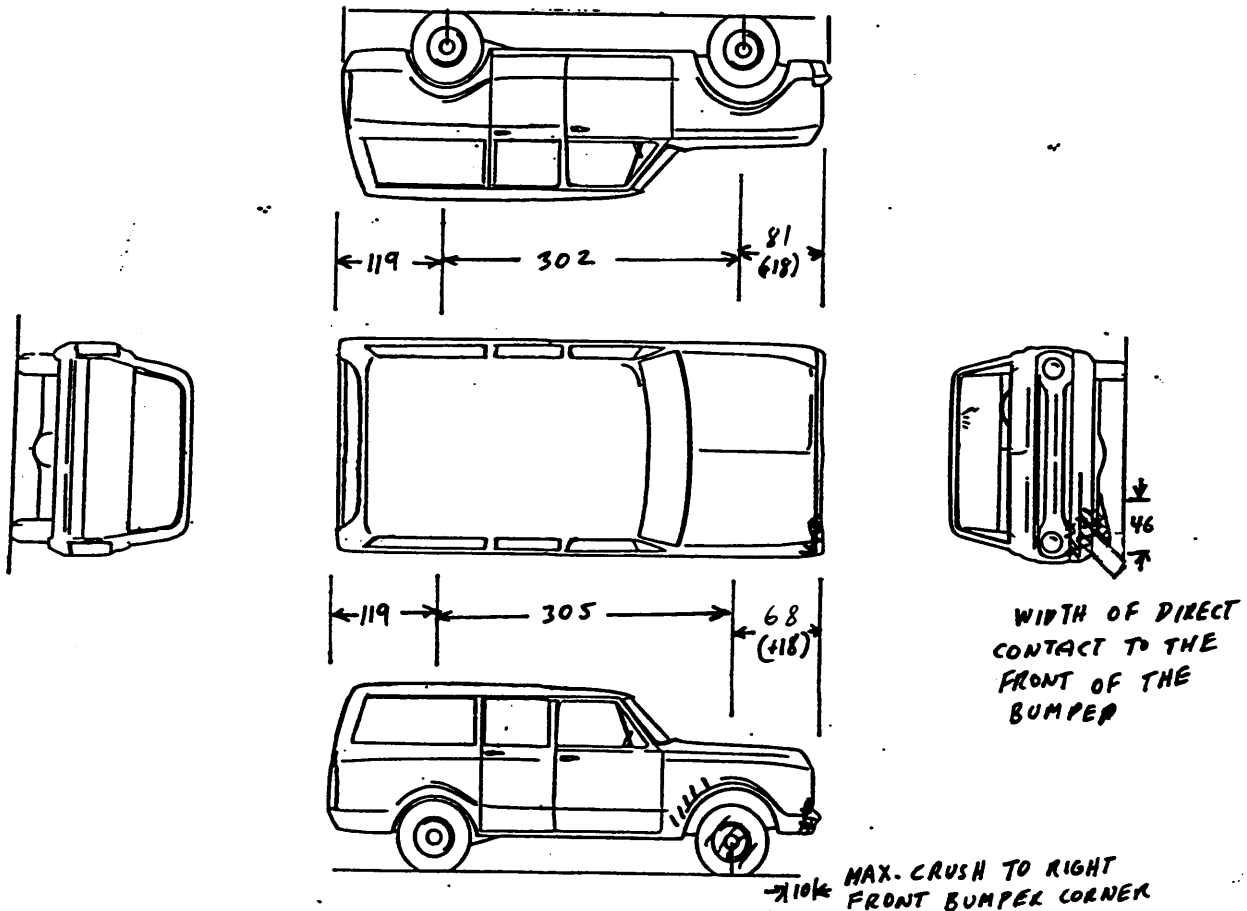
VEHICLE DAMAGE

(Slide 6) Damage to case vehicle (A) was minor. (Slide 7) The direct damage to case vehicle (A) began at the right-front bumper corner and extended 46 cm to the left, resulting in 32 percent vehicle overlap. (Slide 8) The maximum crush was 10 cm to the right-front bumper corner.

Direct Damage Length (DDL) 046 cm

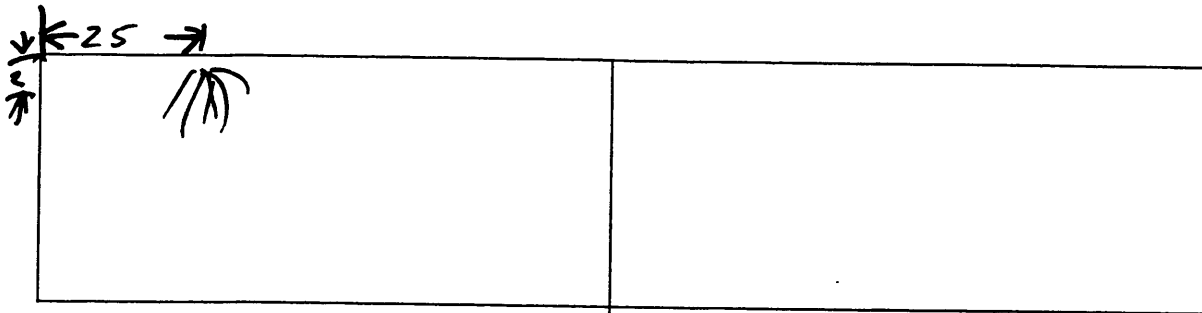
(Slide 13) In the front, the right headlight assembly area was pushed slightly rearward, and (slide 14) the plastic bumper cover was cracked. (Slide 15) There was no other frontal damage, (slide 16) except for a spiderweb crack in the upper portion of the windshield directly above the steering-wheel (slide 17) due to driver hand contact.

CONTACT BY
 LT HAND

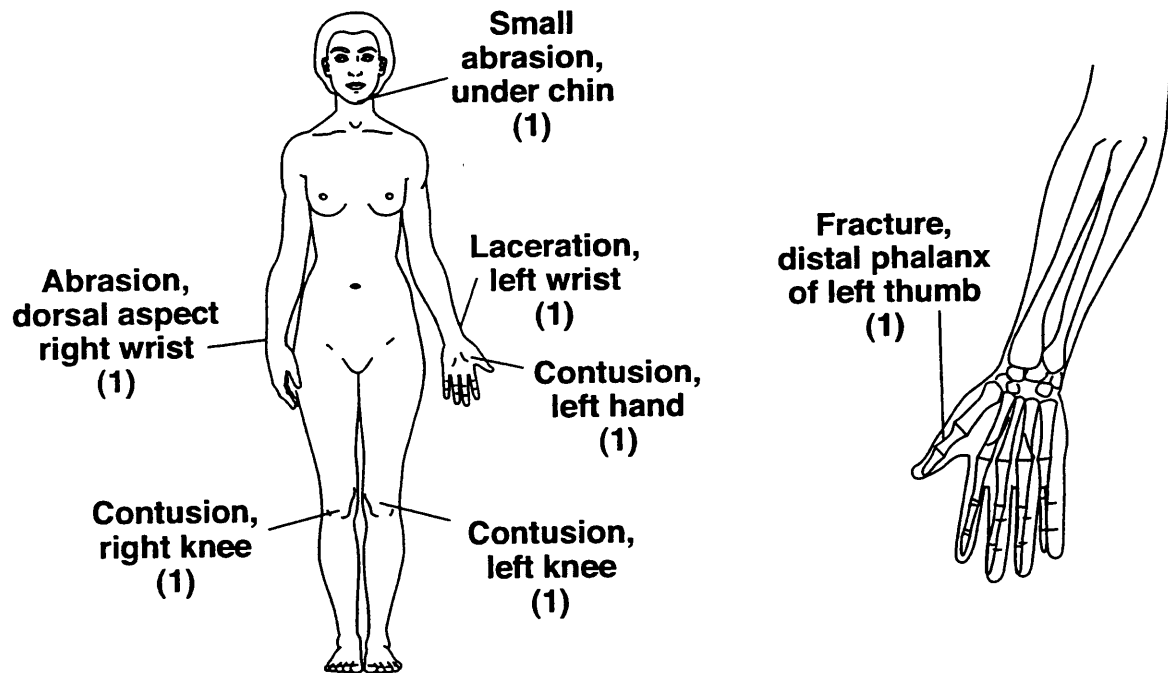
INDICATE LOCATION OF INJURIES.

During the impact, the driver moved forward into the belt restraints and airbag. She sustained a small abrasion under her chin, due to contact by the deploying airbag. She sustained a laceration to her left wrist, due to her watchband being pushed up her forearm by the deploying airbag, (slide 53) as evidenced by a blood smear on the airbag fabric. She sustained a fracture to the distal phalanx of her left thumb and a contusion to her left hand, due to hand contact with the windshield header and/or windshield, (slide 54) as evidenced by the knuckle imprints on the windshield header fabric and the cracked windshield with scuffmarks. This contact was due to the airbag flinging her left arm and hand upward. She sustained an abrasion to the dorsal aspect of her right wrist, possibly due the airbag flinging her right hand downward into her legs or into the seat cushion. She sustained a contusion to her left knee, due to contact with the plastic fuse panel cover, (slides 55 and 56) as evidenced by a small scuff mark and deformation. She sustained contusions to her right knee, due to contact with the plastic knee bolster cover, (slide 57) as evidenced by a small scuff mark. (Slides 58 and 59) There was an unusual looking substance on the vent outlet to the right of center instrument panel, but this did not appear to be related to any occupant contacts or injuries sustained during the crash.

Injury Description	A.I.S.	Injury Source		
		Definite	Probable	Possible
Small abrasion, under chin	1	Airbag		
Abrasion, dorsal aspect of right wrist	1			Driver's leg/seat cushion (airbag fling)
Laceration, left wrist	1	Watchband/airbag		
Fracture, distal phalanx of left thumb	1		Windshield header/windshield (airbag fling)	
Contusion, left hand	1		Windshield header/windshield (airbag fling)	
Contusion, right knee	1	Knee bolster		
Contusion, left knee	1	Fuse panel		
<u>Maximum A.I.S. Level</u>	<u>1</u>			
<u>Injury Severity Score</u>	<u>2</u>
